# Washington State Department of Ecology Hazardous Waste and Toxics Reduction Program

RCRA Site ID: WAH000050091	Facility Name: Treoil Industries	Inspection Date: March 6, 2017
Generator Status: LQG	Facility Address: 4242 Aldergrove Rd., Ferndale WA 98248	Date Report Sent:

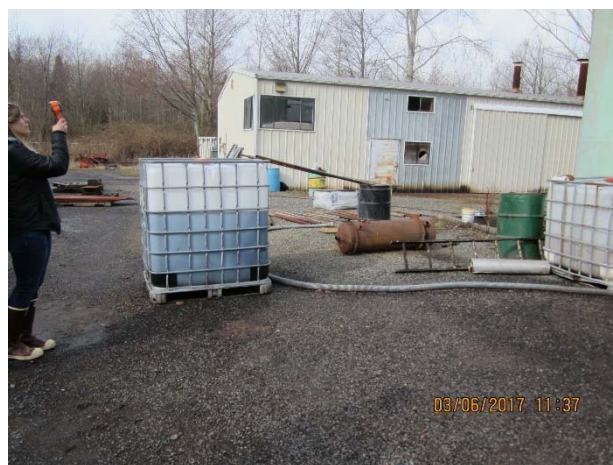
## #31 Graveled Area South of Central Pad

The tote to the left contains glycerin, scheduled for removal March 7. The tote to the right is empty. In the background of this photo is a 20' X 30' warehouse (north-south oriented).

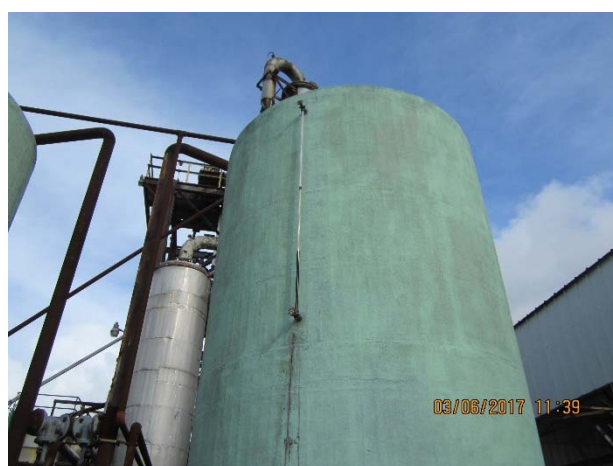
## #32 Central Area, SW of Tank Farm

One of two tanks located in the former "biodiesel well" containment area. This tank had a glass gauge along the side which indicated that the contents were separated into two distinct layers, with around 1/3 being a light brown liquid, and 2/3 a very dark oil. Solution drained from the tank's spigot had an unexpected pH of around 3 (tested using pH paper).

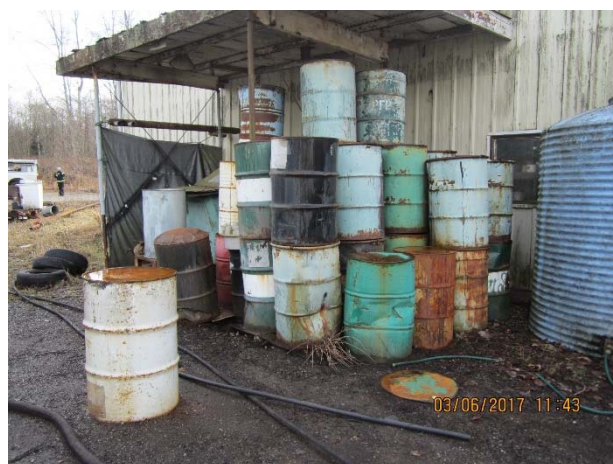
## #33 East – West Warehouse, North Side

Drums stacked along the north side of the 60' X 100' warehouse were either full or empty (not all were checked). None were labeled.

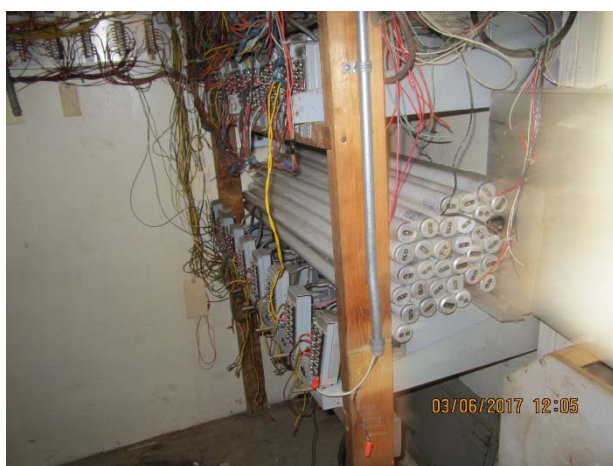
### #45 North – South Warehouse

Universal waste lamps upstairs in electrical room.

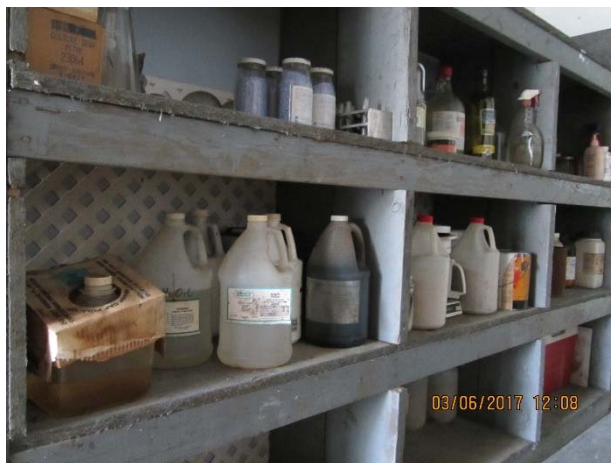
### #46 North – South Warehouse

Chemicals from former lab located in this building. Visible in this photo are glacial acetic acid and unknown oils.

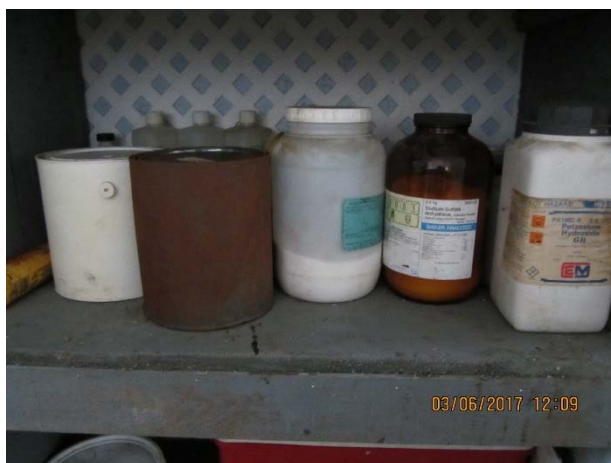
### #47 North – South Warehouse

Visible in this photo are anhydrous sodium sulfate and potassium hydroxide. Other containers were not disturbed for the purpose of reading labels.

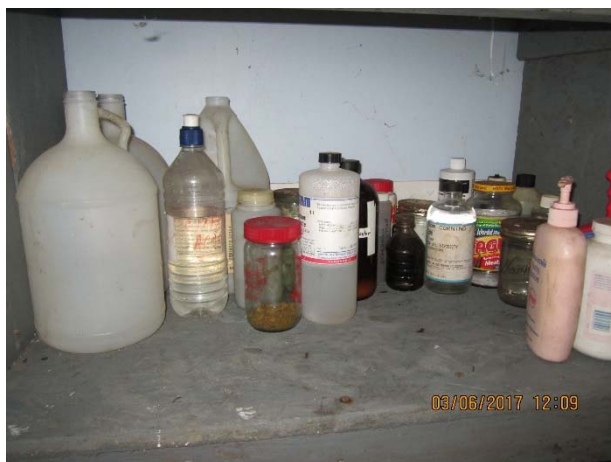
### #48 North – South Warehouse

More lab chemicals, including "citric acid," potassium hydroxide, and others containers not disturbed to read labels.

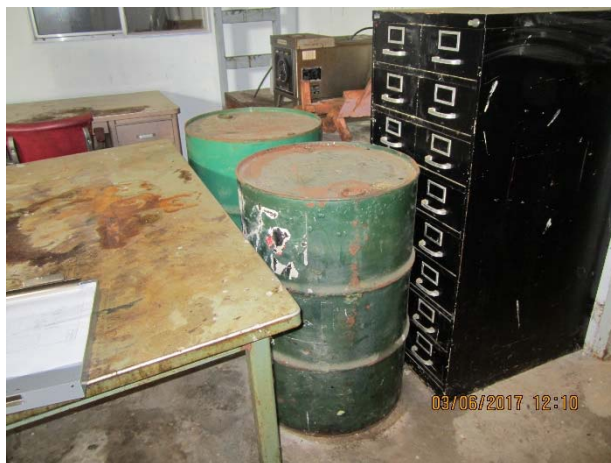
### #49 North – South Warehouse

One of two green 55-gallon drums was empty.  
One was very heavy. Contents unknown.

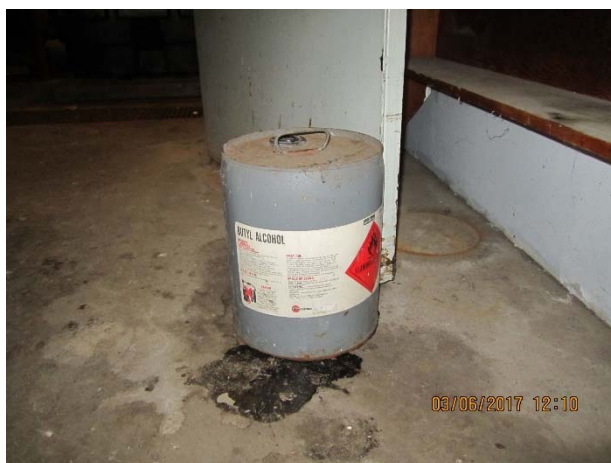
### #50 North – South Warehouse

This five-gallon gallon of butyl alcohol was  
being used as a door stop.

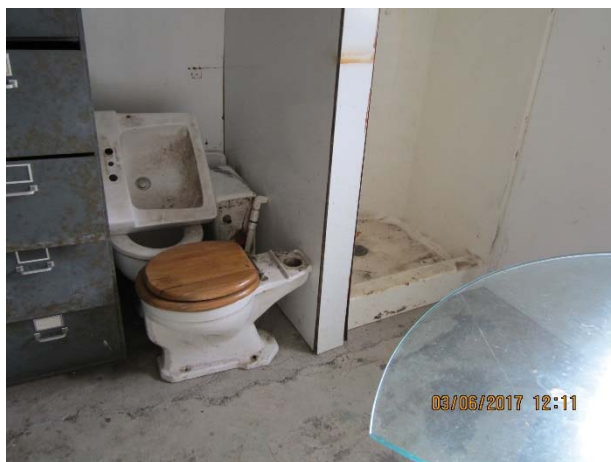
### #51 East - West Warehouse

Bathroom photographed to indicate connection  
to on-site septic system.

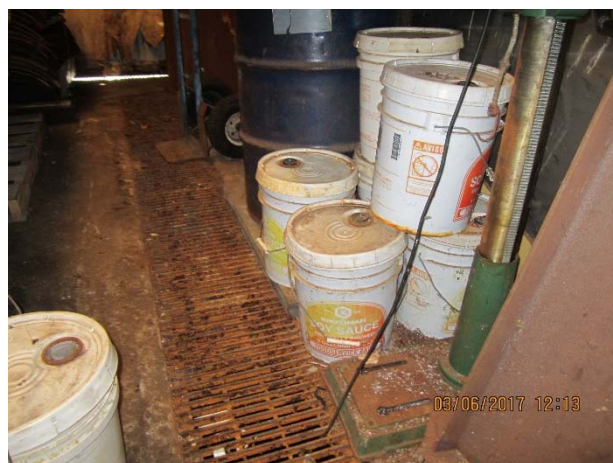
### #53 East – West Warehouse

“Soy sauce” buckets with unknown contents. The blue drum seen in this photo is not labeled. Several inches of water visible in floor trench drain.

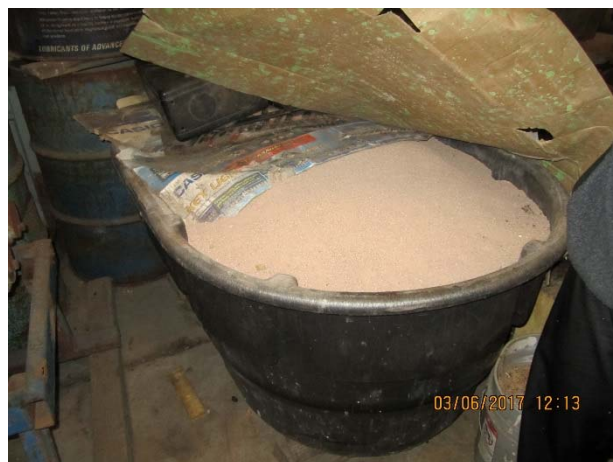
### #54 East – West Warehouse

Sand or sandblast grit. Unknown but present in various forms, in containers and drums.

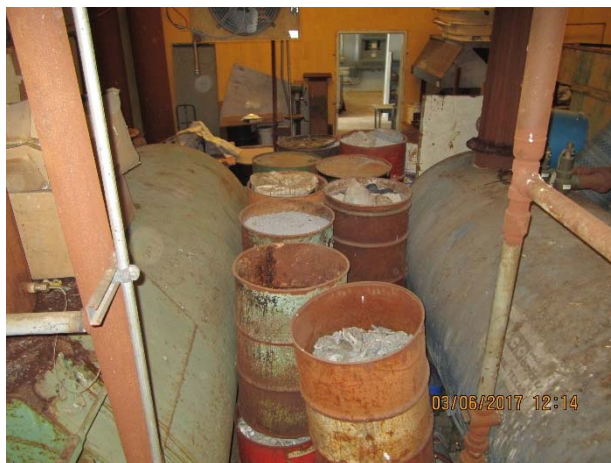
## #58 East – West Warehouse

Sandy and gravelly material within drums could have been used grit, ash from a furnace, or refractory materials.

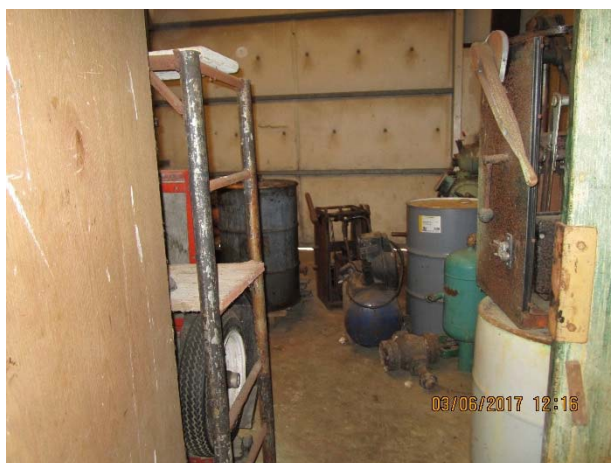
## #59 East – West Warehouse

More drums with unknown contents.

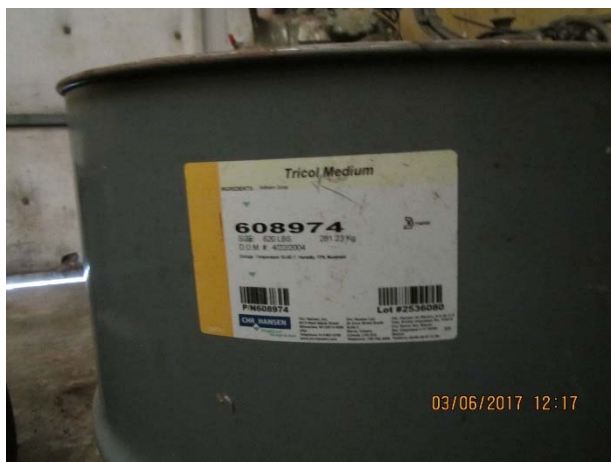
## #60 East – West Warehouse

Closed 55-gallon drum labeled “Tricol Medium.”

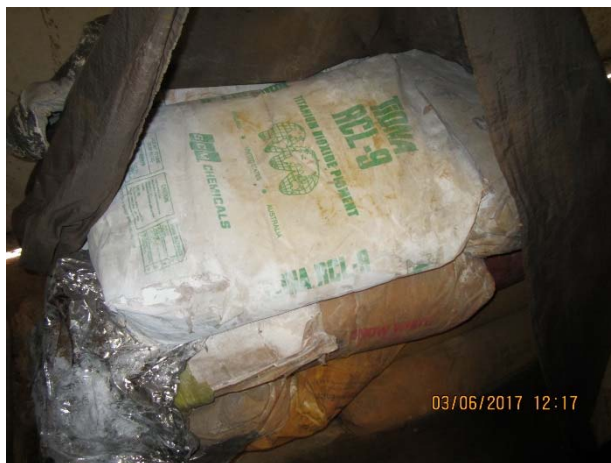
### #61 East – West Warehouse

Numerous bags of titanium dioxide pigment.

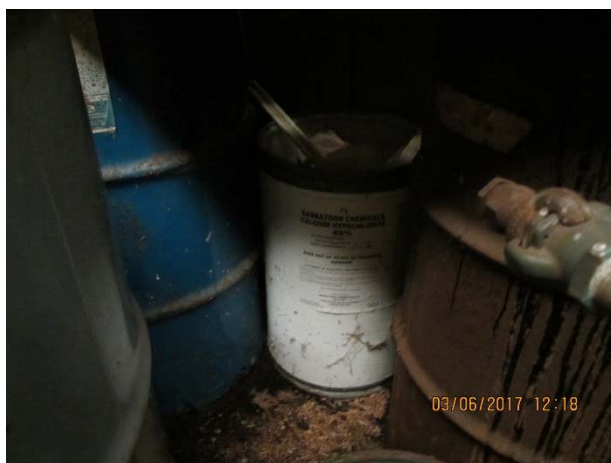
### #62 East – West Warehouse

Smaller drum labeled "Calcium hypochlorite 65%." Other drums have unknown contents.

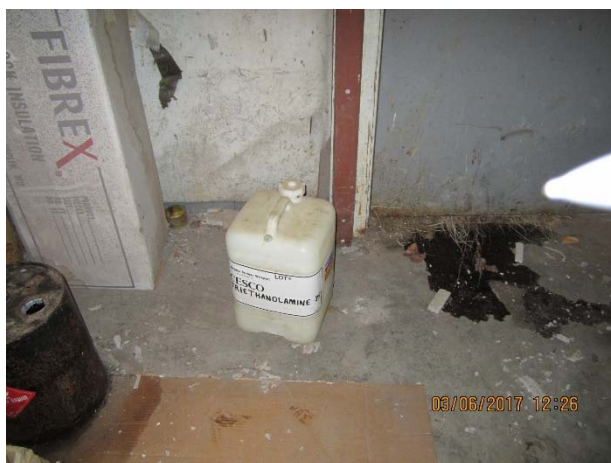
#65 East – West Warehouse

Triethanolamine, 5 gallons.

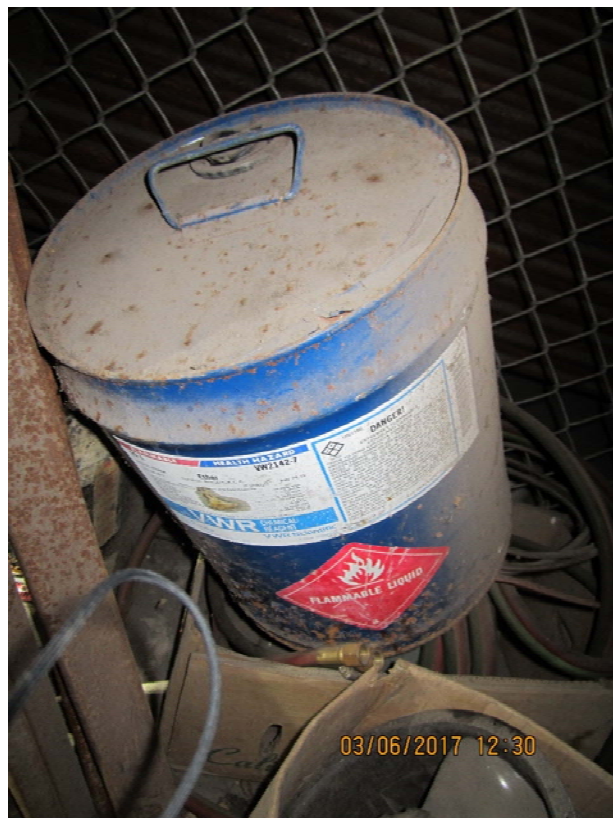
### #70 East – West Warehouse

A five-gallon can of ether, found in the caged area long the north wall of the warehouse.

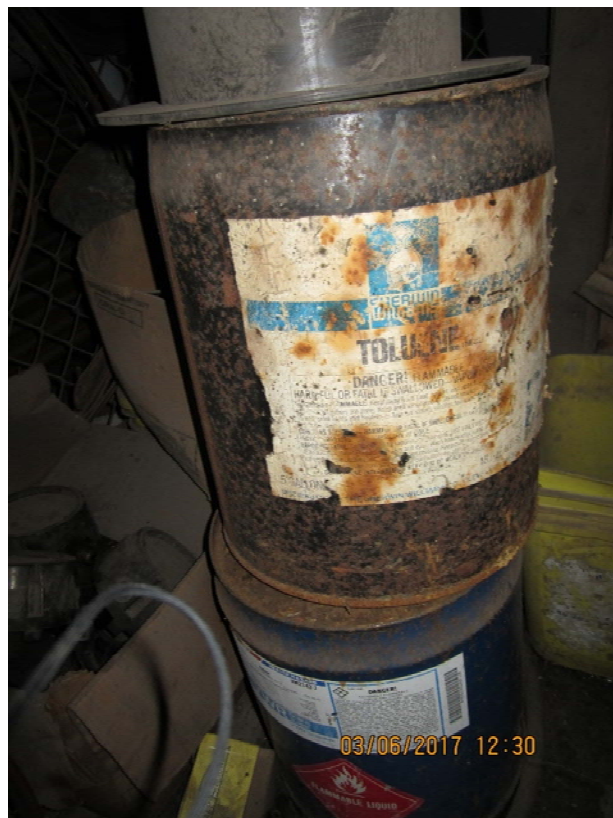
### #71 East – West Warehouse

A five gallon container of ether and a five-gallon container of toluene found stacked in the open “cage” along the north wall of the warehouse.

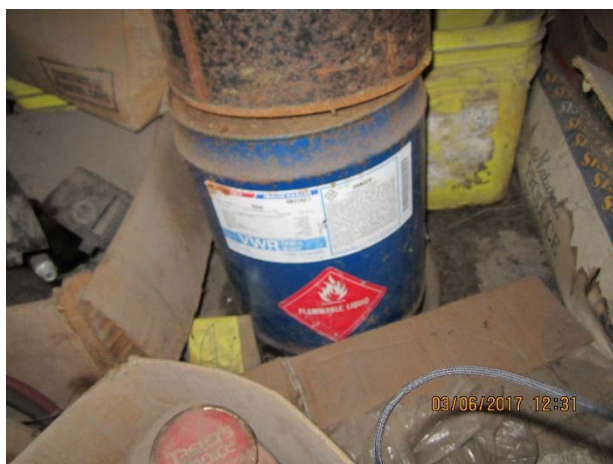
### #72 East – West Warehouse

Close up picture of ether shown in photo 71.
